**NBSIR 73-263**

# **Fire Endurance Tests of Unprotected Wood-Floor Constructions for Single-Family Residences**

**July 1973**

**Final Report**

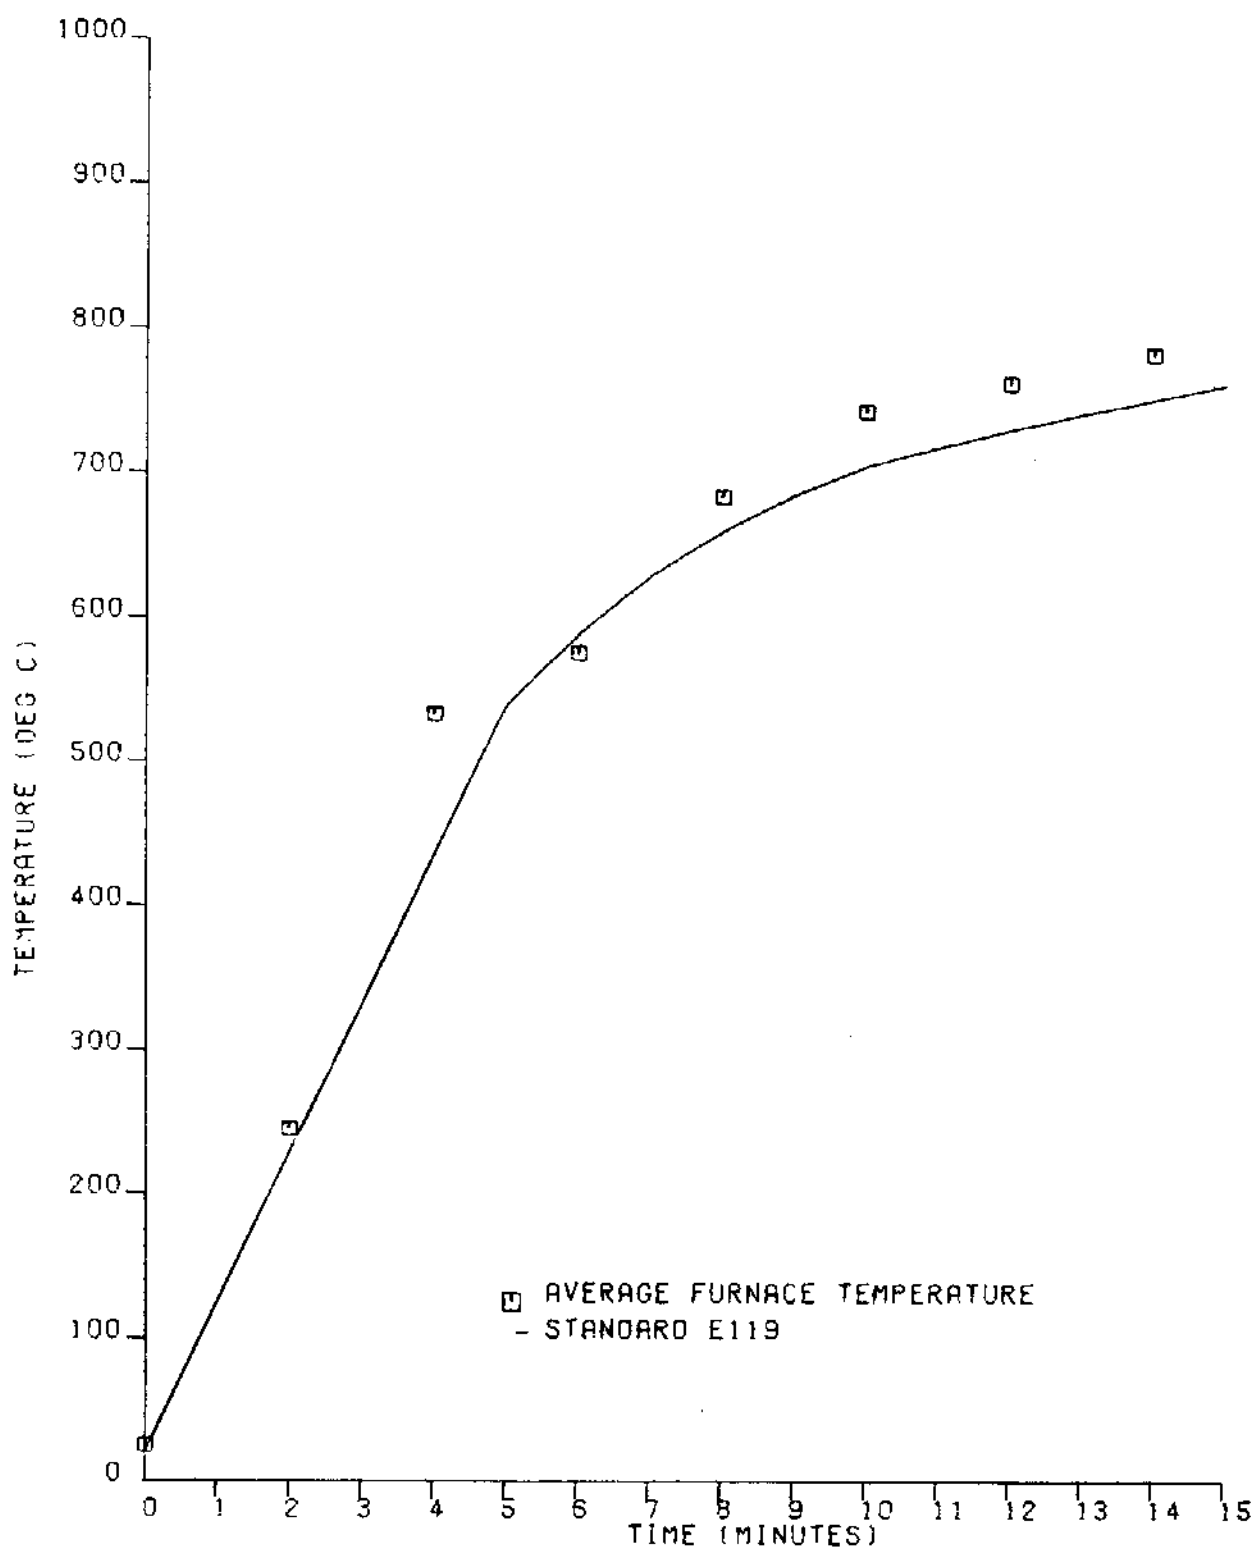
FIGURE 8. Average Furnace Temperature for #L-1 Compared with Standard E119

The average temperature inside the furnace was measured by twelve protected thermocouples and was made to follow the standard ASTM E119-70 temperature-time curve by automatic control of the gas flow to the burners, which is shown in figure 8.

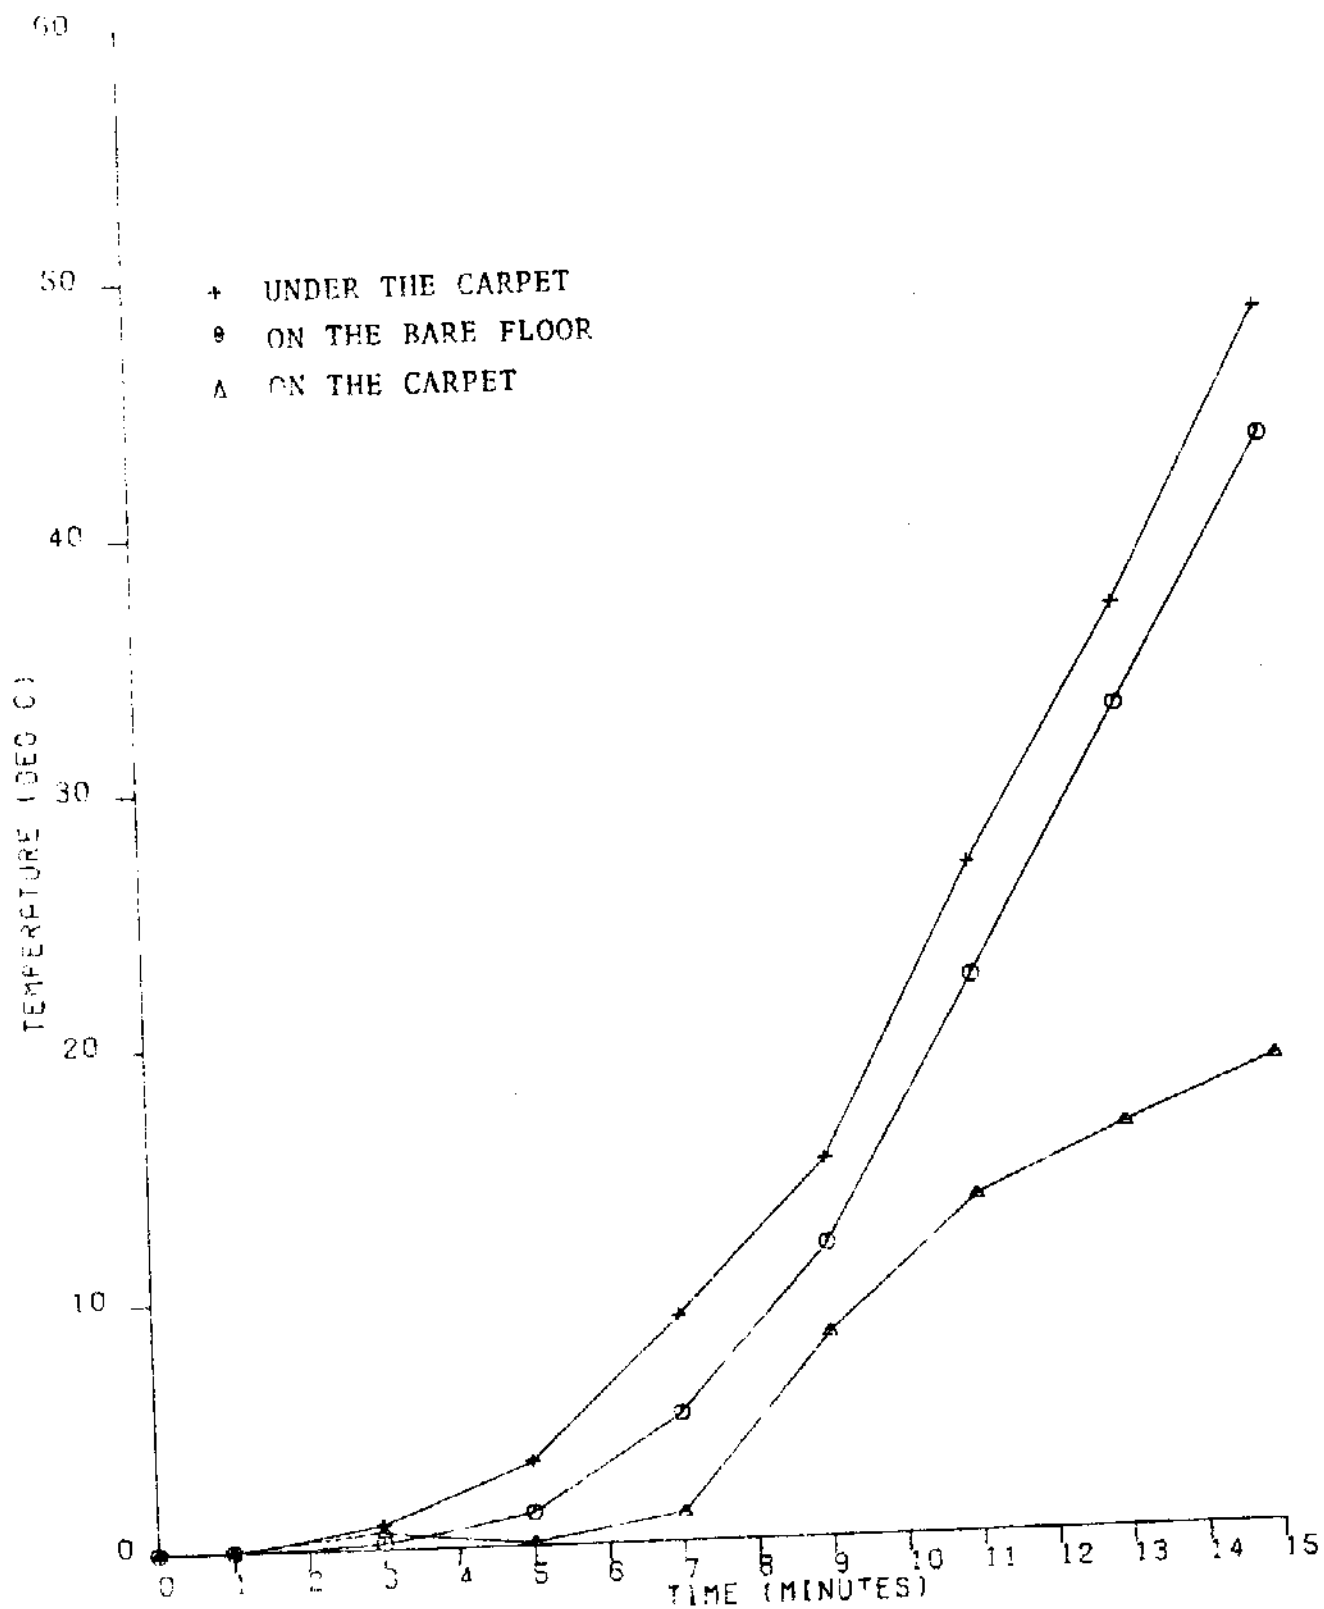
FIGURE 11. Average Surface Temperature Rises on Bare Plywood Floor, Under the Carpet, and on the Carpet (Test #L-1)

The average temperature rise of the surface thermocouples on the "bare" floor was less than 75°C when the test was terminated after 15 minutes. A single thermocouple on the carpet exceeded a 50°C rise, with a reading of 80°C indicating that it may have been directly over a nailhead. The average temperatures of the "bare" floor and the carpet-finished floor are shown along with the average temperature beneath the carpet in figure 11.

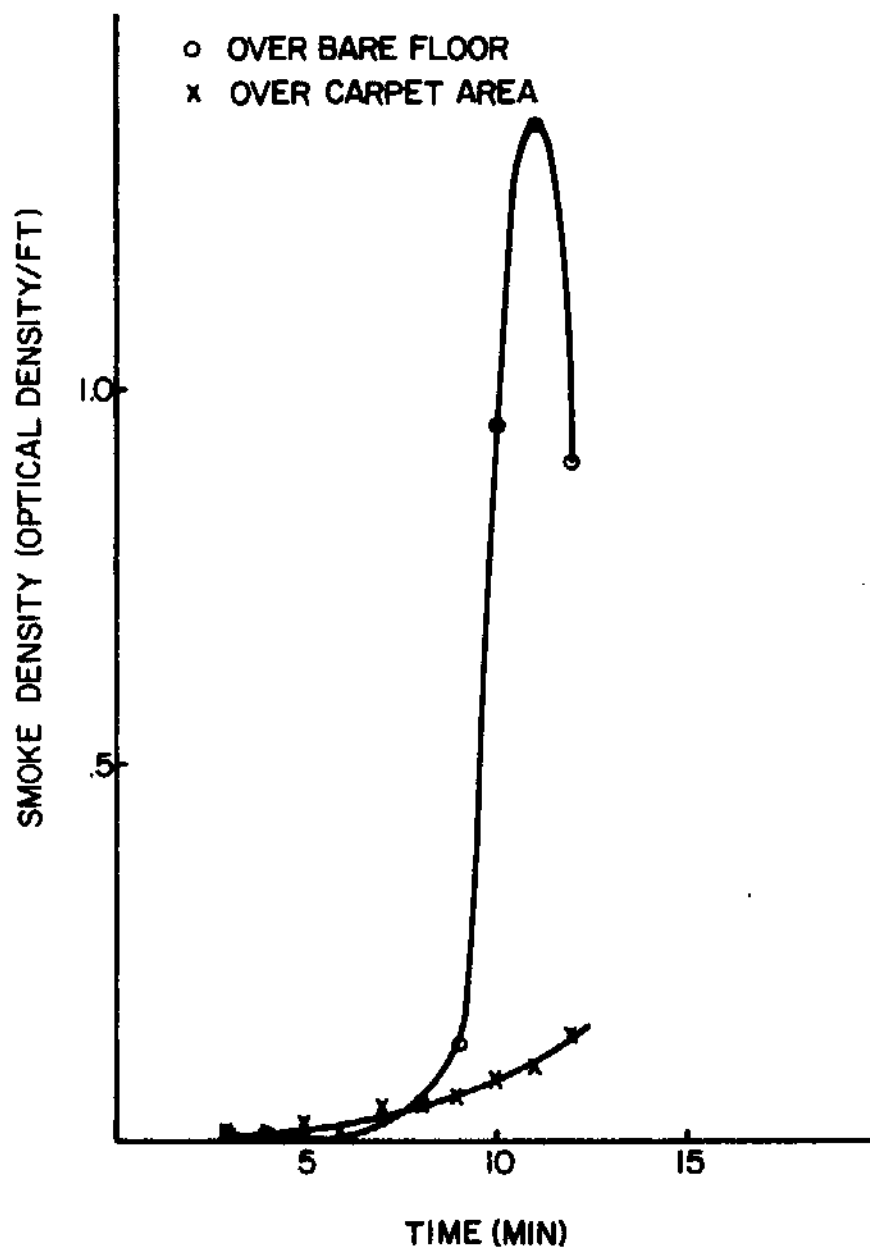
FIGURE 12. Smoke Density, Test #L-1

The smoke meter on the "bare" floor showed a sudden increase in smoke at about 9 minutes, which was more than 4 minutes before "flame through" was noticed. The smoke level indicated by the meter over the carpet-finished floor was considerably less. Smoke meter transmission is given in Table 2, Appendix I and figure 12.

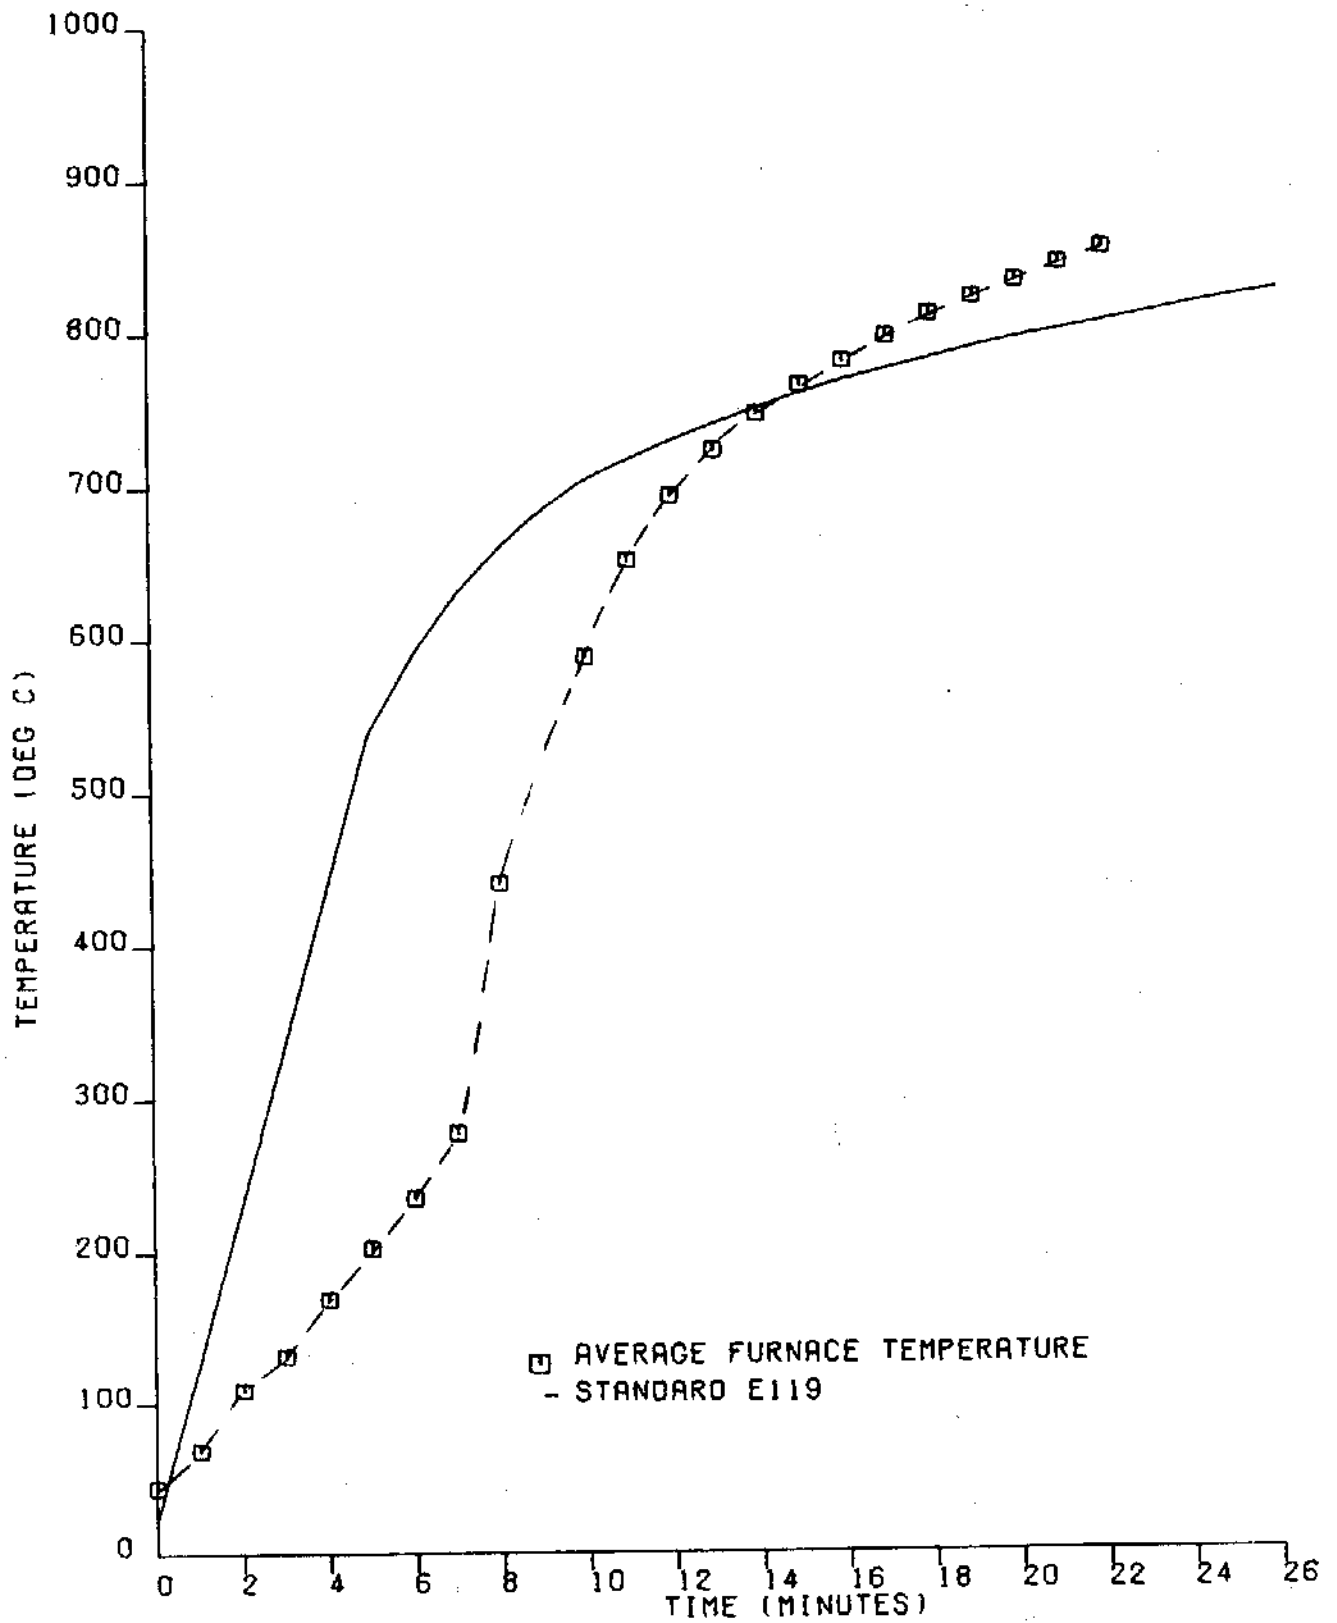
FIGURE 17. Average Furnace Temperatures for Test #S-1 Compared with Standard E 119

Some difficulty with the furnace control was experienced at the beginning of this test causing the furnace temperature-time curve to be below the standard temperature-time curve (see figure 17). Flame through occurred at 21 min:43 sec. The corrected time of flame through, according

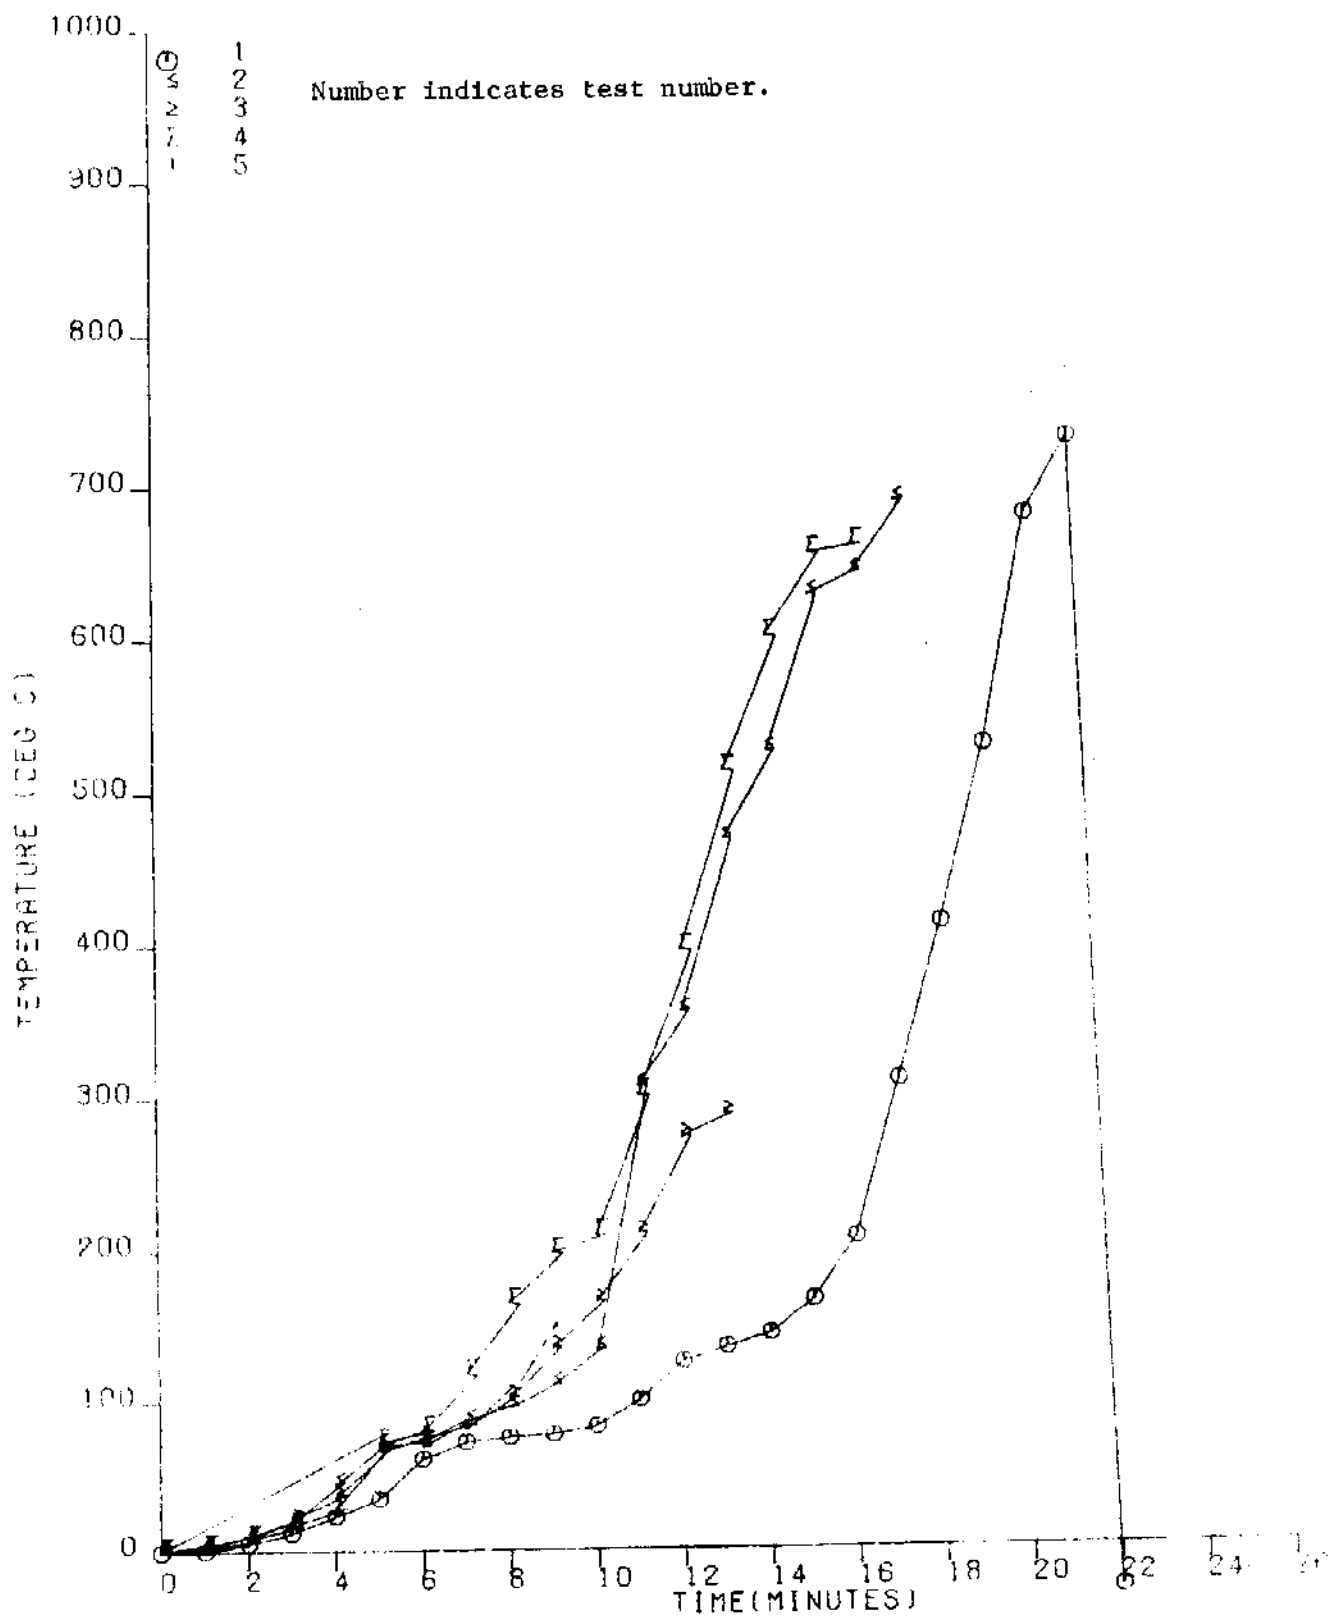
Fig. 23 Temperature Rises at Half Depth For 2X2 Tests #S-1 - 5

Figures 23 and 24 show the temperature changes at half depth for the small scale tests. In figure 24 the slope of curve 7 is flatter than the others, which is explained by the blocking under the joint protecting the joint from the fire.

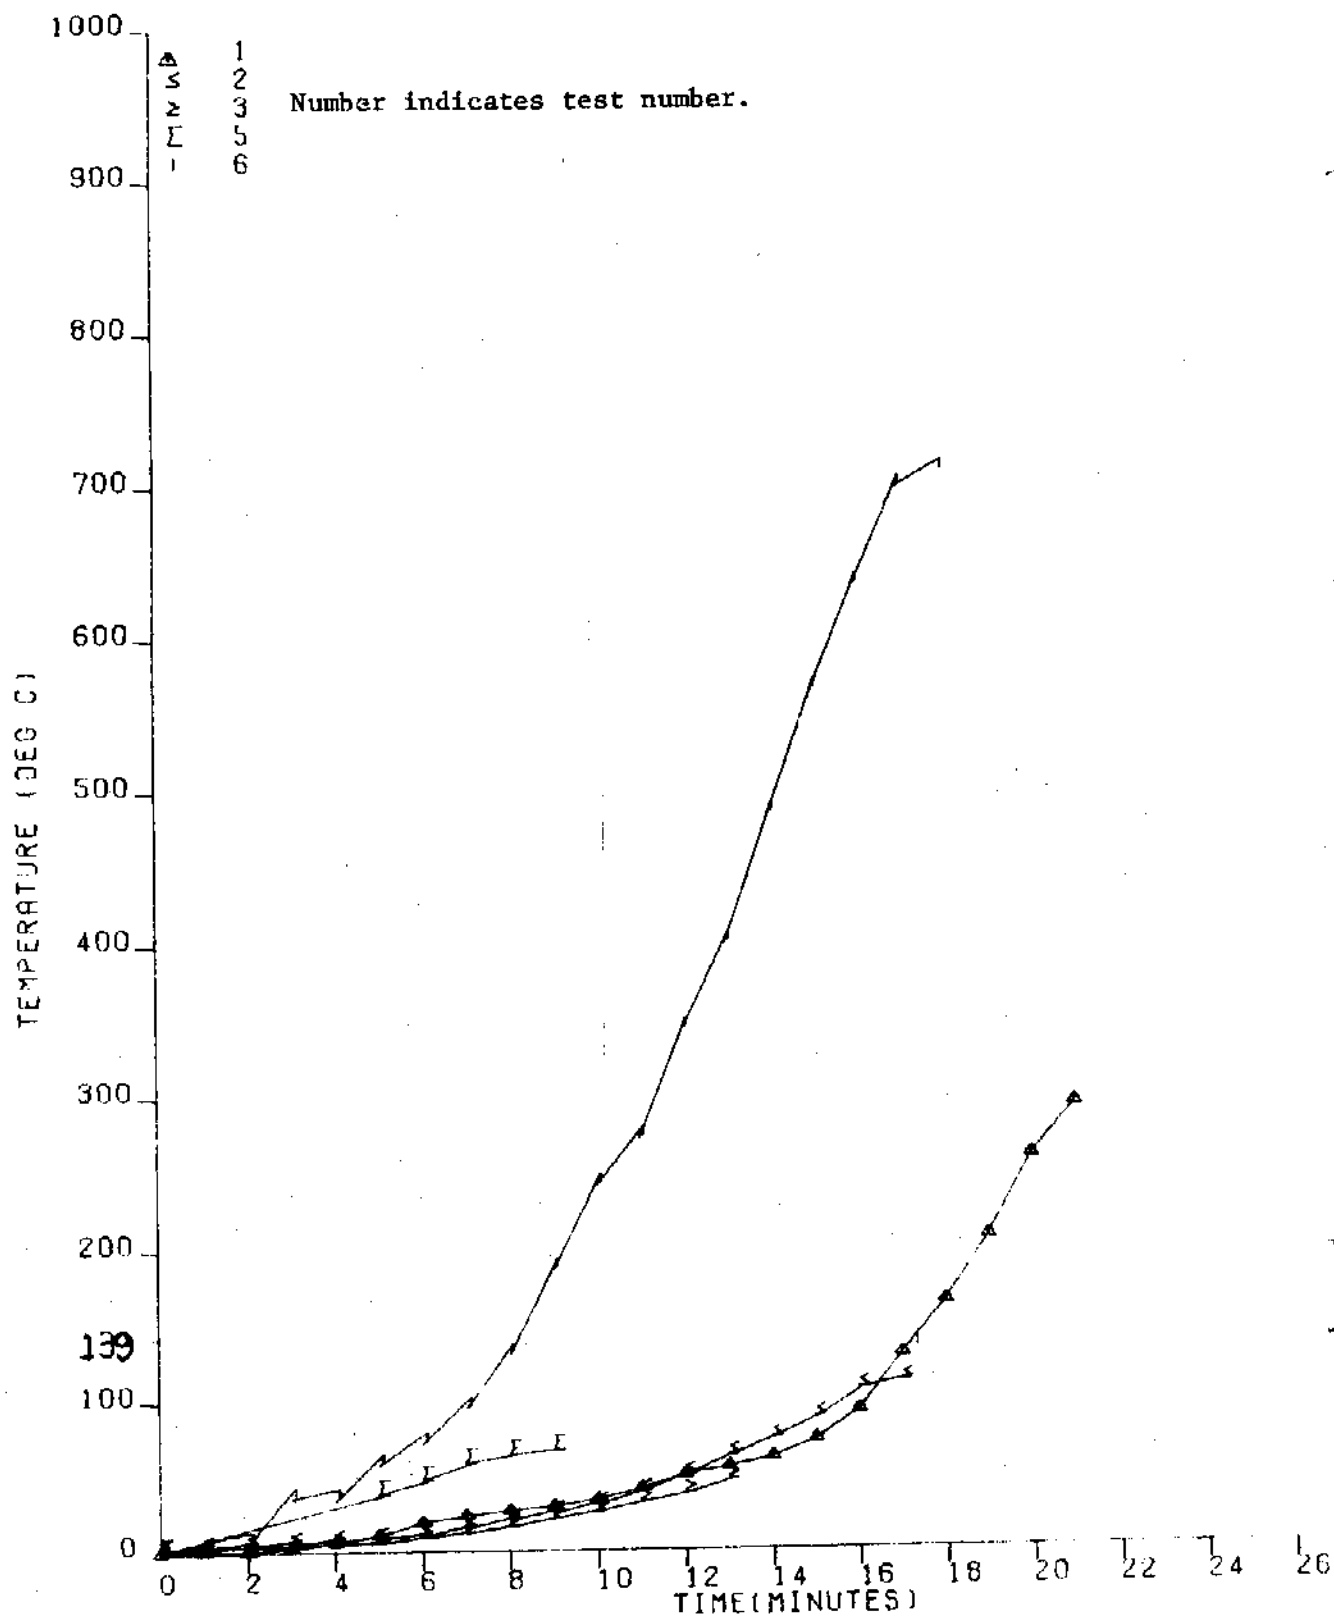
Fig. 25. Temperature Rises on the Bare Floor for Tests #S-1 - 6

The temperature changes on the bare floor and on the carpet surface are shown in Figures 25, 26 and 27. The temperature failure due to the average temperature rise of 139°C on the unexposed surface occurred a few minutes (1-7 minutes) earlier than the failure by flame through. These are shown in Table 1 of Appendix I.

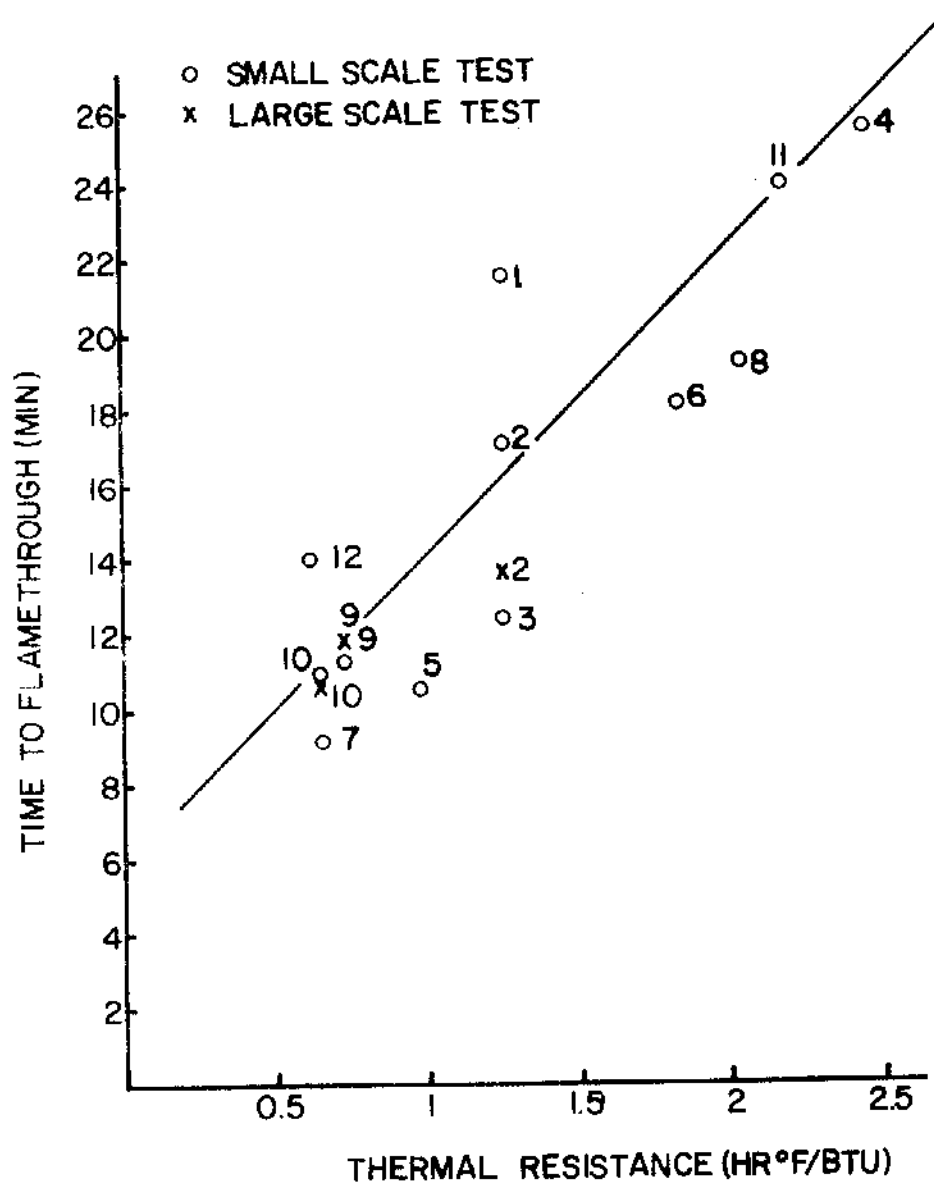
Fig 28 Thermal RESISTANCE of Floor Construction Vs Flamethrough Time

Figure 28 illustrates the influence of the thermal conductivity of various materials on the time of "flame through" under free convection conditions and at room temperature. It is apparent that construction #S-4 (1/2 in. plywood + 1/2 in. plywood + 1/8 in. gap + carpet) has the largest value of thermal resistance and requires the longest time for the flame to penetrate through the floor. It can be also seen in figure 28, that empirically there is a linear relation between the thermal resistance and the "flame through" time. The developed slope K is 0.133 (BTU/°F).
